Drains Done Differently.

South Innisfil Creek Drain (SICD) Improvement Ecological Enhancements

Unique Innovations

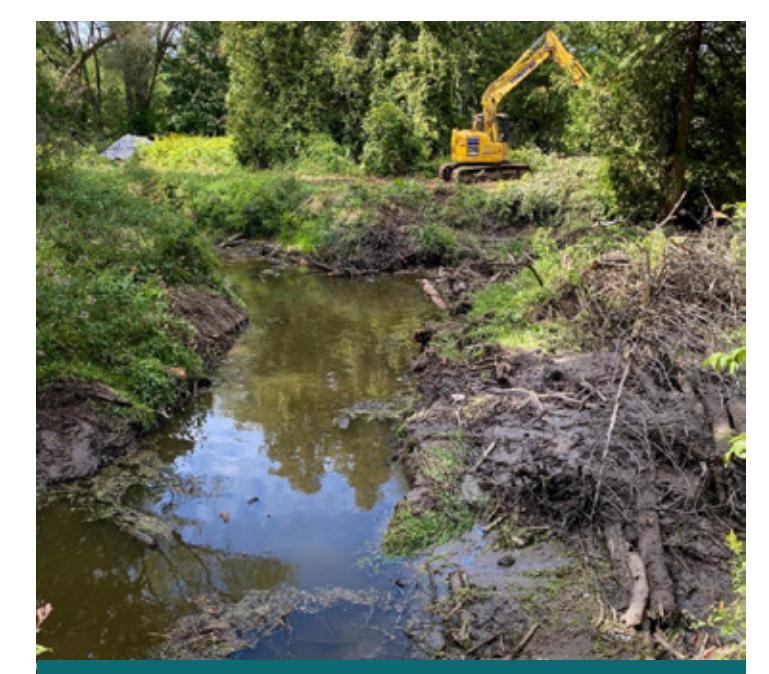
Debris and sediment accumulation were blocking the flow of water at a 90-degree bend in the Drain. The flowpath had to be re-established, but the blockage had created a backwater area that had value for habitat refuge, as well as flood storage during higher run-off / flow events.

During construction (looking upstream); log jam and blockage pulled/pushed right to open the drain and establish the main flow path

- The existing Woody Material (WM) was removed from the obstruction and used to begin to establish the Leaky Berm;
- The sediment buildup was excavated and the thalweg or main flow path in the Drain was re-established;

- The WM placed in the Leaky Berm was supplemented with additional locally sourced WM; the upstream end of the WM was buried into the drain bank:
- Ballast (the removed sediment) was added on top of the WM; sod mats were placed on the exposed drain banks; the ballast, sod mats, and WM was tamped into place;

- The WM structure was securely pinned in place with the excavator by inserting or pushing pairs of overlapping and abutting sharpened wood pieces of appropriate diameter (150 to 200mm) and length (3.0 to 4.0m) at about 45-degrees to the drain bottom to ensure the material was held down and prevented from floating or lifting during high flows; and

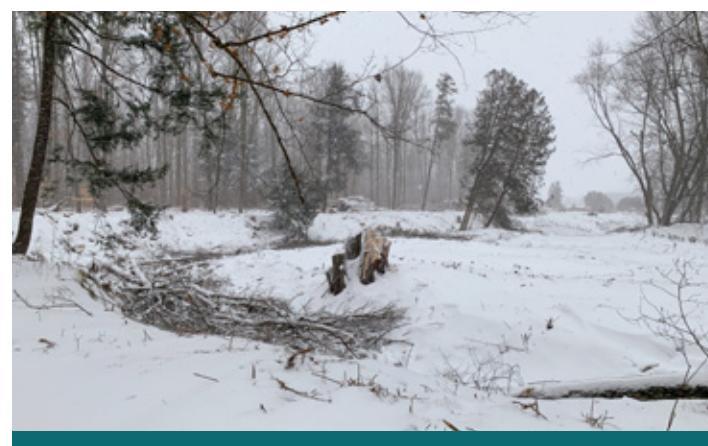
A remnant oxbow adjacent to the main drain acted as flood storage during high runoff events and provided terrestrial habitat.

Remnant oxbow area after clearing woodlot and felling deciduous trees (conifers salvaged for later WD structures)

- Supplement the remnant oxbow by felling trees into the bottom to provide additional refuge and habitat;
- The oxbow was not filled and the spoils from the widening of the adjacent portion of the SICD were pushed east and west to maintain the existing feature; and

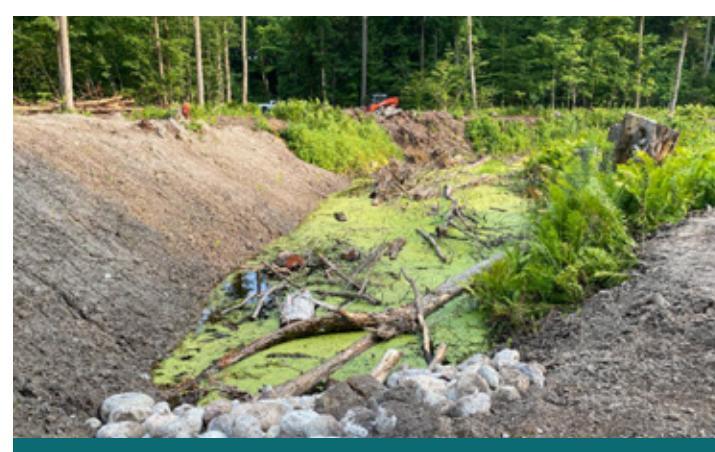
New offset wetland feature c/w french drain outlet

• A positive outlet was installed above the wetland bottom (a wood and stone French Drain) for partial emptying of the wetland after a major event, while still retaining adequate capacity in it to provide the intended function as habitat for green frogs, turtles, and waterfowl.

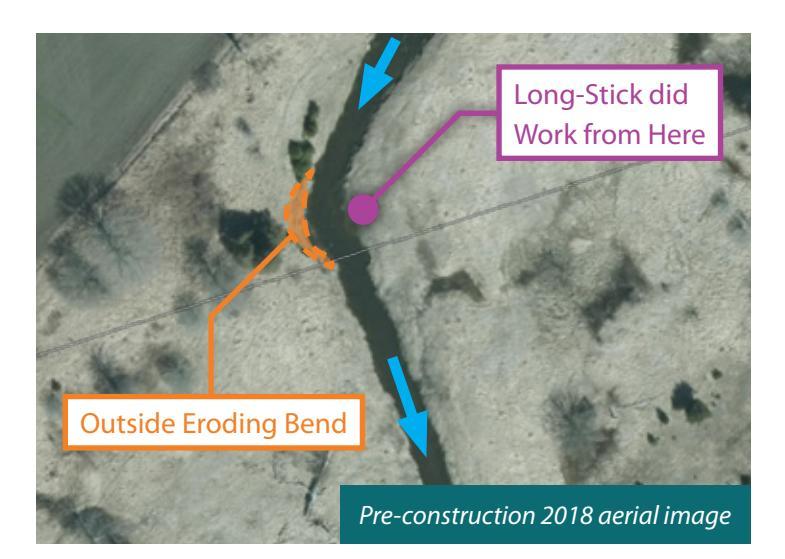
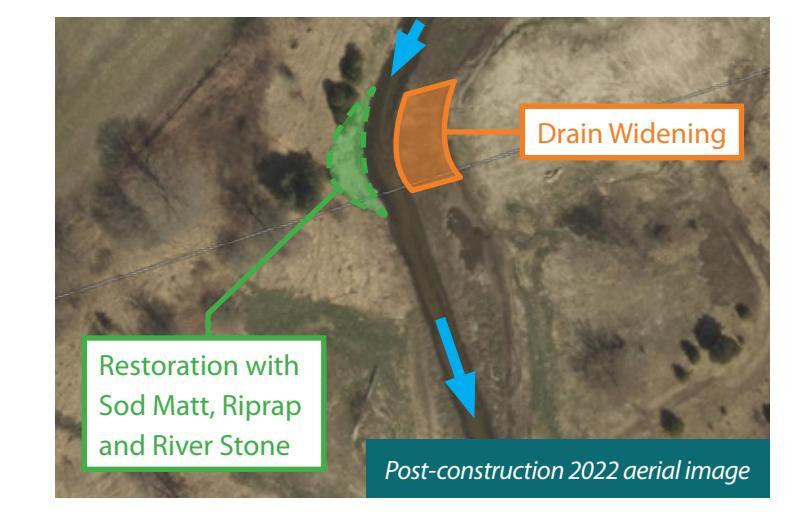
The first bend in the Drain downstream of a major highway required extensive stabilization work. It was severely eroded and slumping (see 2018 Spring Aerial and Pre-Construction photo), and the almost vertical bank was approximately 3.0-4.0m in height above the base flow water surface.

A number of abandoned nests were discovered in the upper 1.0-1.2m of the bank. Bank Swallow (a threatened species) activity was observed in this area during a 2019 field reconnaissance. Therefore, it became a project objective to improve Bank Swallow habitat in the area and the work was completed as follows:

- Using a long stick excavator from the opposite drain bank (before the drain was widened), the toe of the eroding slope was built-out with a mixture of large stone and the main flow path was slightly narrowed;
- Riprap was placed on the eroding slope above the base (low) flow water level and river stone was placed along the water line extending down to the bottom of the drain;
- Sod mats were placed by the excavator at the upstream and downstream extents of the bend and combined with the river stone;
- The upper 1.0 to 1.2m of the bank was left vertical and the overhanging potential swallow predator access vegetation was hand-trimmed and removed; and
- No Bank Swallow habitat was impacted, and habitat conditions were enhanced.
