Drains Done Differently.

South Innisfil Creek Drain (SICD) Improvement Ecological Enhancements

Unique Innovations

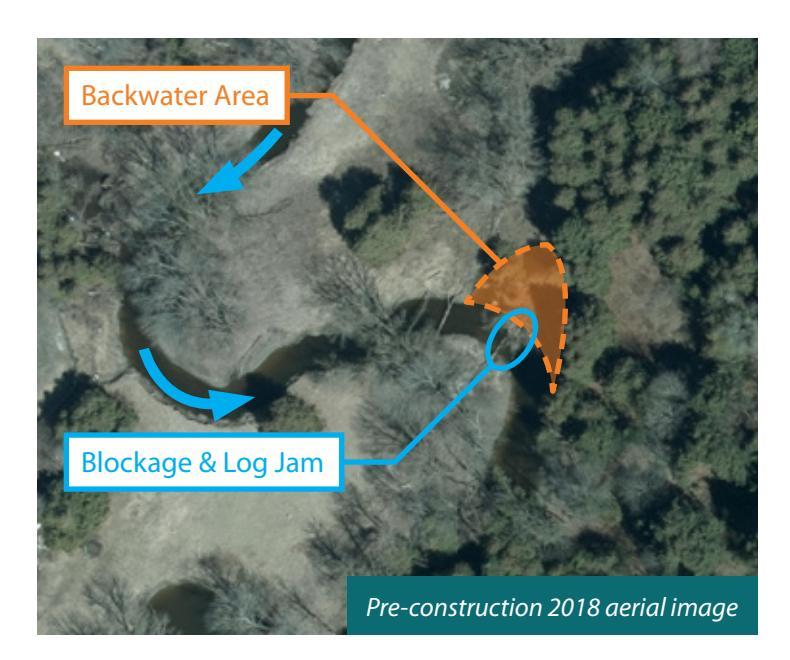
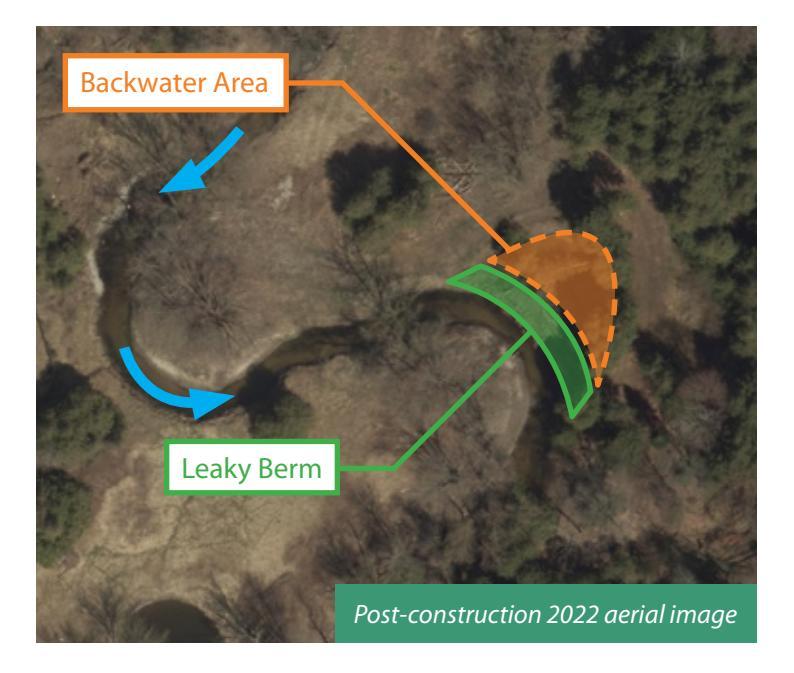
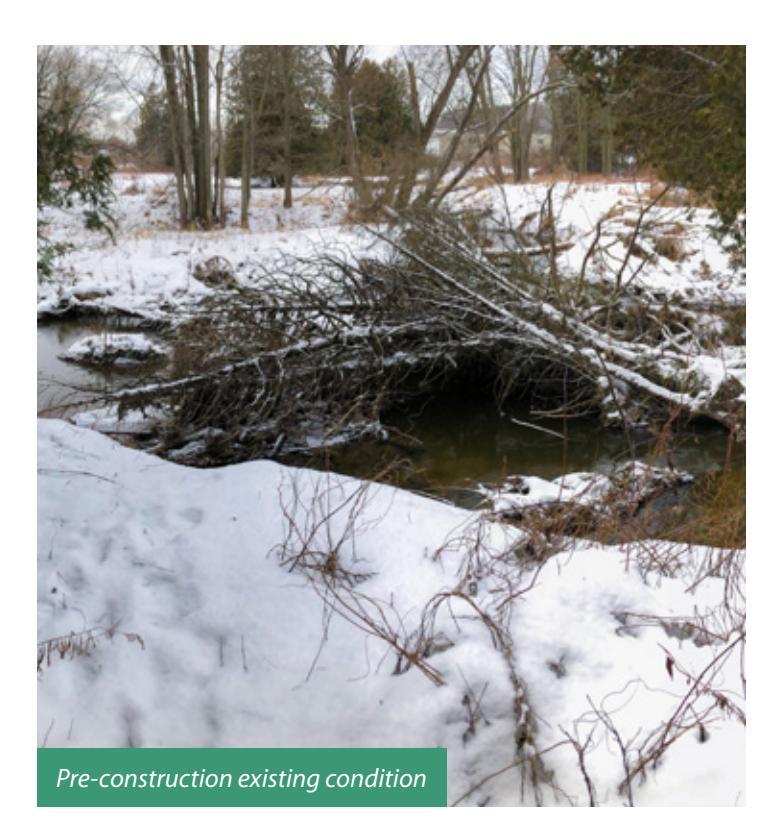
Debris and sediment accumulation were blocking the flow of water at a 90-degree bend in the Drain. The flowpath had to be re-established, but the blockage had created a backwater area that had value for habitat refuge, as well as flood storage during higher run-off / flow events.

- The existing Woody Material (WM) was removed from the obstruction and used to begin to establish the Leaky Berm;
- The sediment buildup was excavated and the thalweg or main flow path in the Drain was re-established;

- The WM placed in the Leaky Berm was supplemented with additional locally sourced WM; the upstream end of the WM was buried into the drain bank:
- Ballast (the removed sediment) was added on top of the WM; sod mats were placed on the exposed drain banks; the ballast, sod mats, and WM was tamped into place;

- The WM structure was securely pinned in place with the excavator by inserting or pushing pairs of overlapping and abutting sharpened wood pieces of appropriate diameter (150 to 200mm) and length (3.0 to 4.0m) at about 45-degrees to the drain bottom to ensure the material was held down and prevented from floating or lifting during high flows; and

- The main flow path was re-checked to ensure it was adequate after manipulating all of the materials in the Leaky Berm.

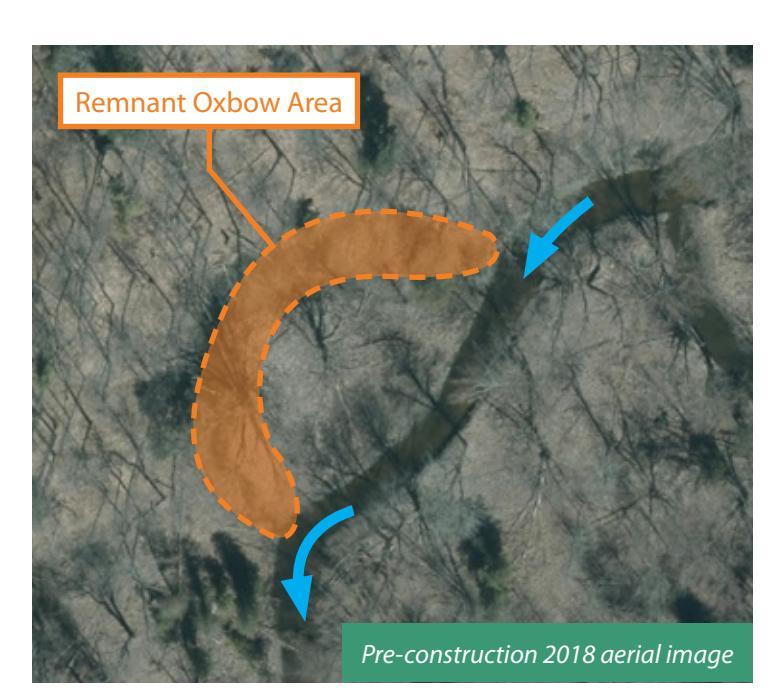
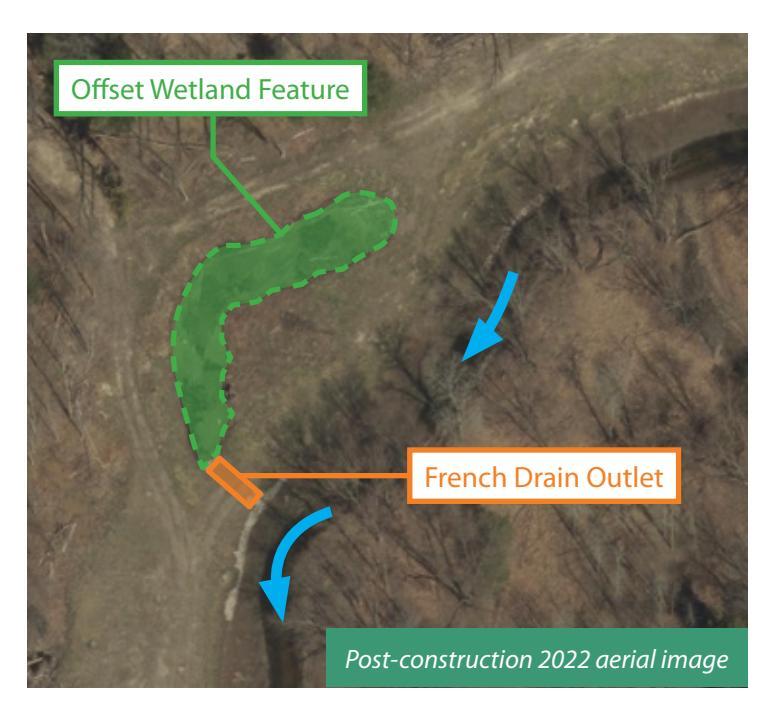
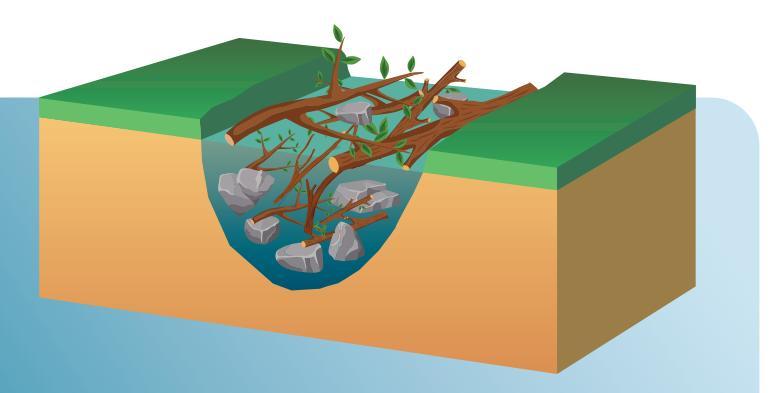
A remnant oxbow adjacent to the main drain acted as flood storage during high runoff events and provided terrestrial habitat.

- Supplement the remnant oxbow by felling trees into the bottom to provide additional refuge and habitat;
- The oxbow was not filled and the spoils from the widening of the adjacent portion of the SICD were pushed east and west to maintain the existing feature; and

• A positive outlet was installed above the wetland bottom (a wood and stone French Drain) for partial emptying of the wetland after a major event, while still retaining adequate capacity in it to provide the intended function as habitat for green frogs, turtles, and waterfowl.

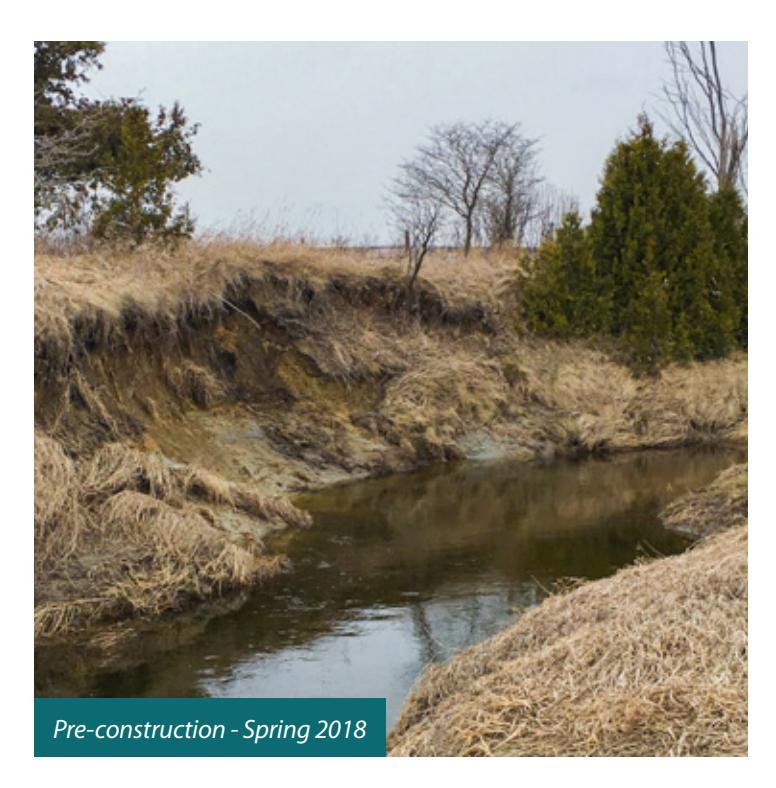
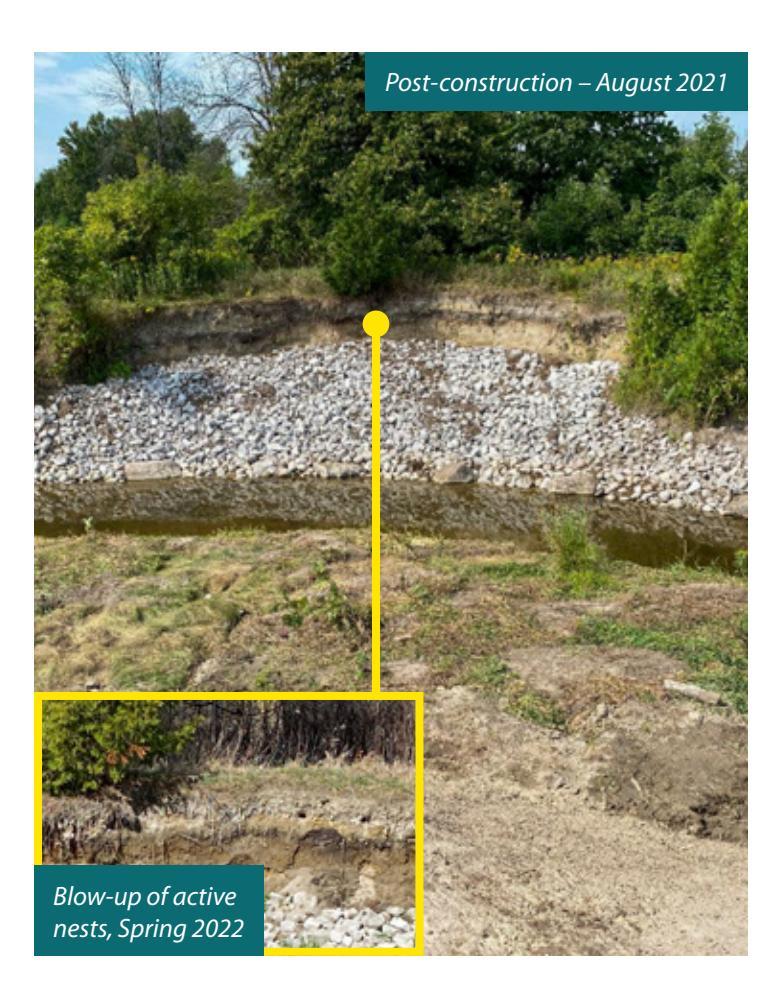
The first bend in the Drain downstream of a major highway required extensive stabilization work. It was severely eroded and slumping (see 2018 Spring Aerial and Pre-Construction photo), and the almost vertical bank was approximately 3.0-4.0m in height above the base flow water surface.

A number of abandoned nests were discovered in the upper 1.0-1.2m of the bank. Bank Swallow (a threatened species) activity was observed in this area during a 2019 field reconnaissance. Therefore, it became a project objective to improve Bank Swallow habitat in the area and the work was completed as follows:

- Using a long stick excavator from the opposite drain bank (before the drain was widened), the toe of the eroding slope was built-out with a mixture of large stone and the main flow path was slightly narrowed;
- Riprap was placed on the eroding slope above the base (low) flow water level and river stone was placed along the water line extending down to the bottom of the drain;
- Sod mats were placed by the excavator at the upstream and downstream extents of the bend and combined with the river stone;
- The upper 1.0 to 1.2m of the bank was left vertical and the overhanging potential swallow predator access vegetation was hand-trimmed and removed; and
- No Bank Swallow habitat was impacted, and habitat conditions were enhanced.
